Final Report

Atatürk Soil, Water, and Agricultural Meteorology Research Institute

1. Lake Gala water quality studies

1. Results of water quality studies performed on Lake Gala

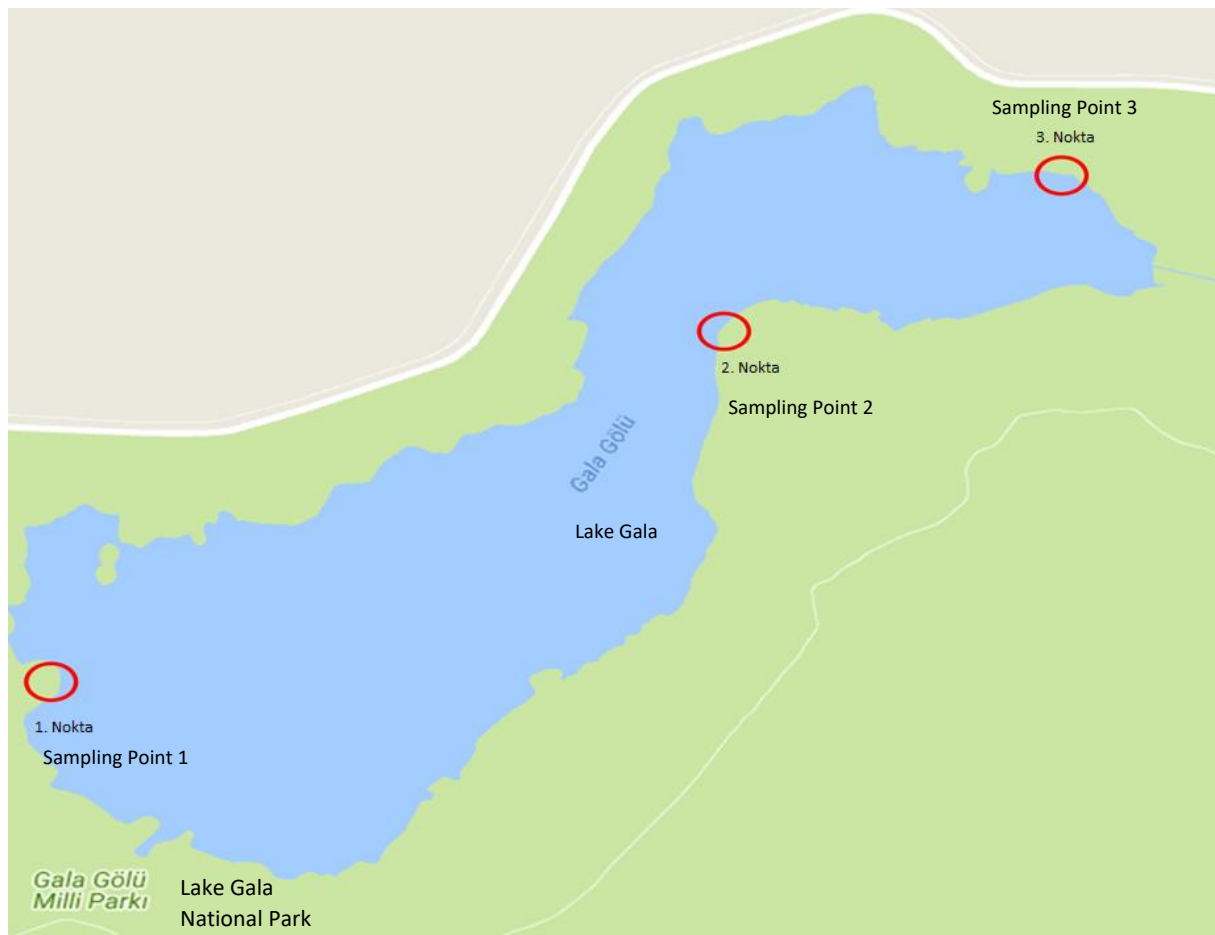
Sampling points were specifically selected as representative points for Lake's water quality. Such sampling points are as shown in Figure 1.

Figure1. Lake Gala Sampling Point

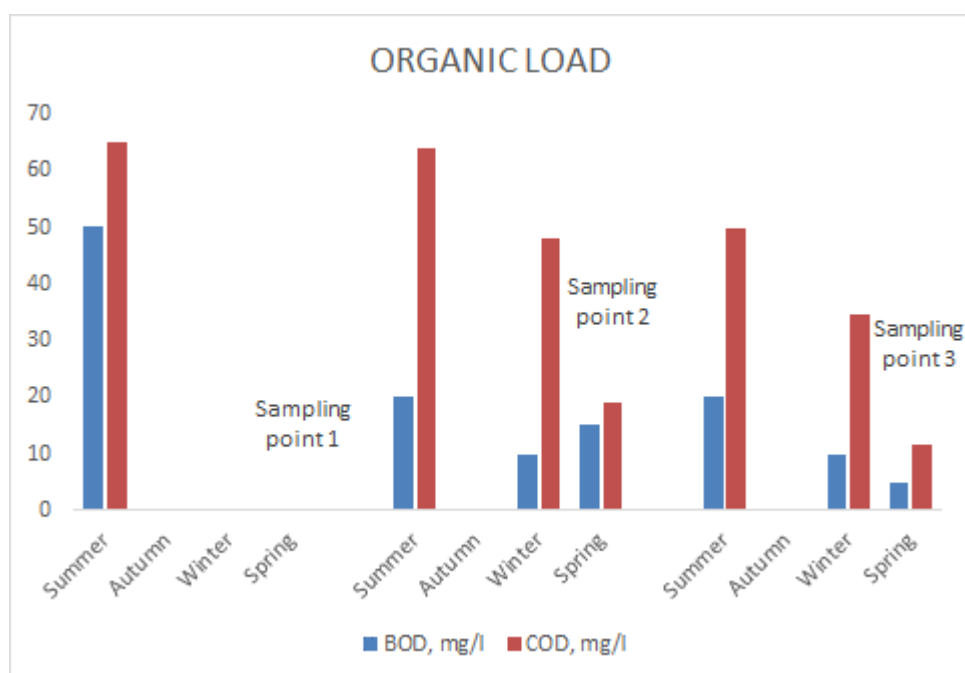
Figure 2. Seasonal graphic of BOD and COD parameters

Oxidation parameters, i.e. BOD and COD, were only measured in July 2017, and Lake's water was classified as very contaminated in terms of BOD, and slightly contaminated in terms of COD.

Water sample taken from the second sampling point was determined to have good and average quality in terms of BOD values while determined to have good quality in terms of COD values.

BOD values were determined to be between 5 and 20 mg L⁻¹ (Class II and III), COD values were determined to be between 11,6 and 49,87 mg L⁻¹ (Class I and II).

Some parameters of water samples taken from three different sampling points in Lake Gala were analyzed seasonally, and are shown in the graphics below.

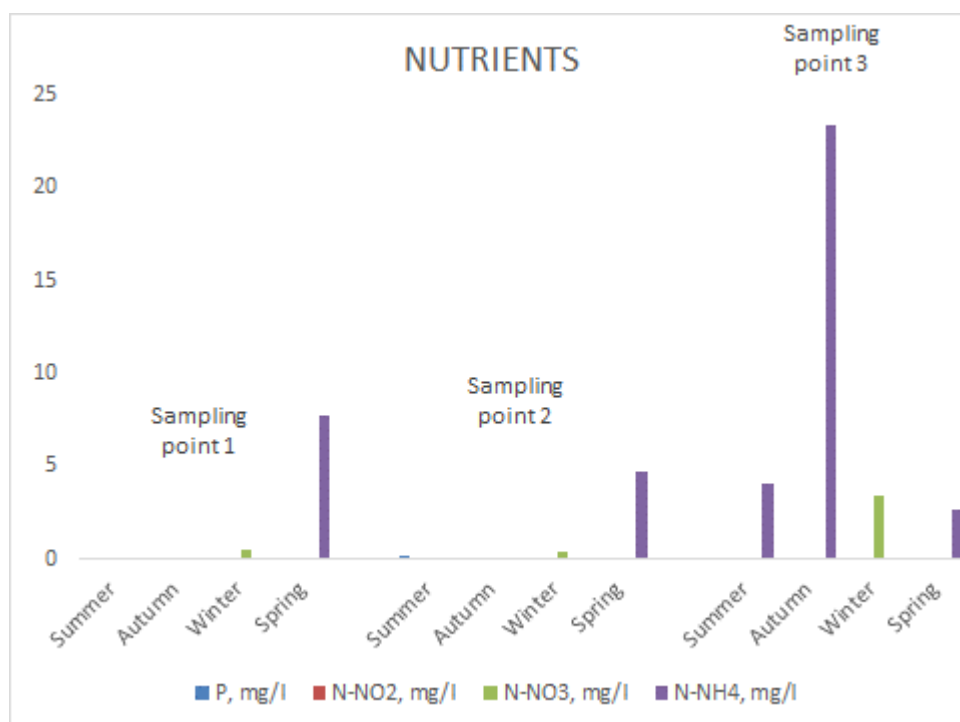
Figure 3. Seasonal graphic of P, HN₄-N, NO₃-N, and NO₂-N parameters

In terms of nutrients parameter, $\text{NH}_4^+\text{-N}$ was measured to be between 5,18 and 9,24 mg/l, and accordingly Lake's water is classified as very contaminated in terms of that parameter. There is no concern with respect to $\text{NO}_3^-\text{-N}$, and no $\text{NO}_2^-\text{-N}$ has been detected. Phosphorus values vary between 19,22 and 195,23 $\mu\text{g/l}$ which indicates a good water quality. High $\text{NH}_4^+\text{-N}$ values may result from intensive use of urea and ammonium in the paddy fields around the Lake used to grow rice, which flows into the Lake water through underground and surface waters after being discharged from the paddy fields.

Regarding nutrients, just like the other two sampling points, only NH-N values were determined to be high (Class IV) while NO₃-N ve NO₂-N caused no contamination.

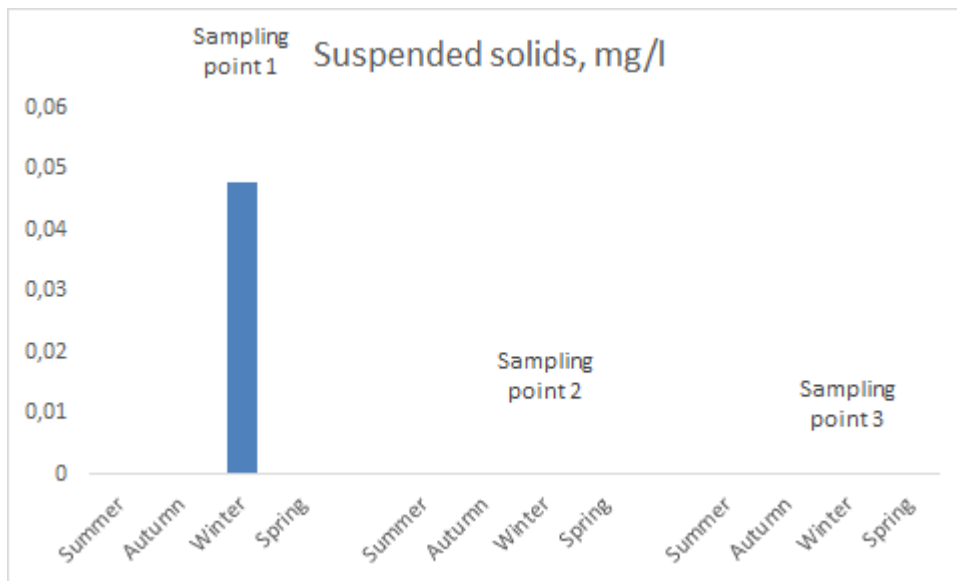
Figure 4. Seasonal graphic of suspended solids (SS)

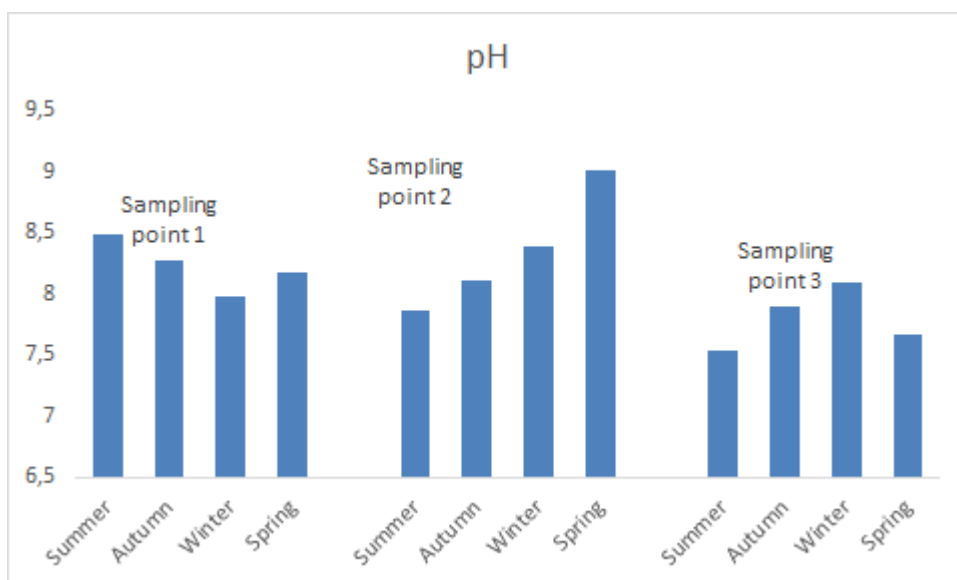
Figure 5. Seasonal graphic of pH values

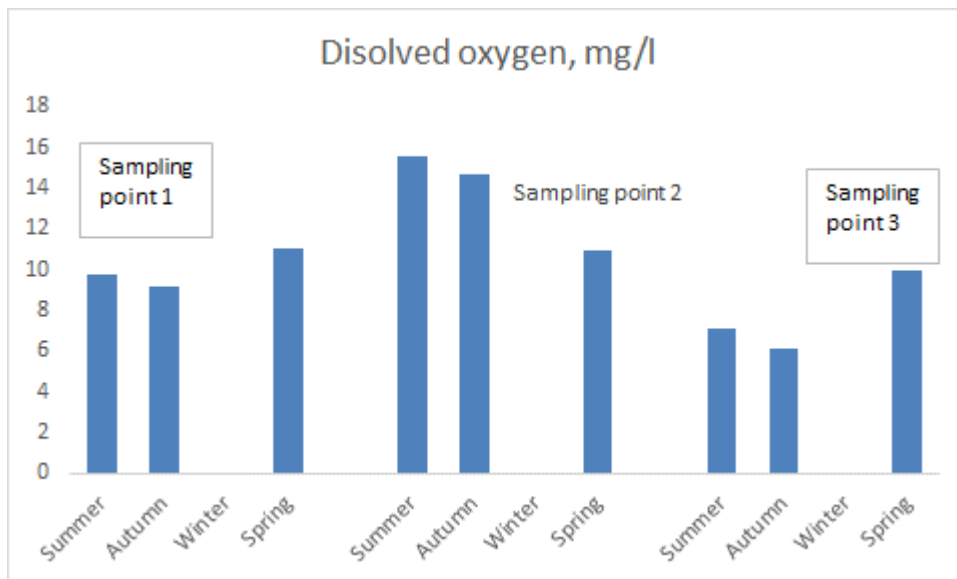
Figure 6. Seasonal graphic of dissolved oxygen values

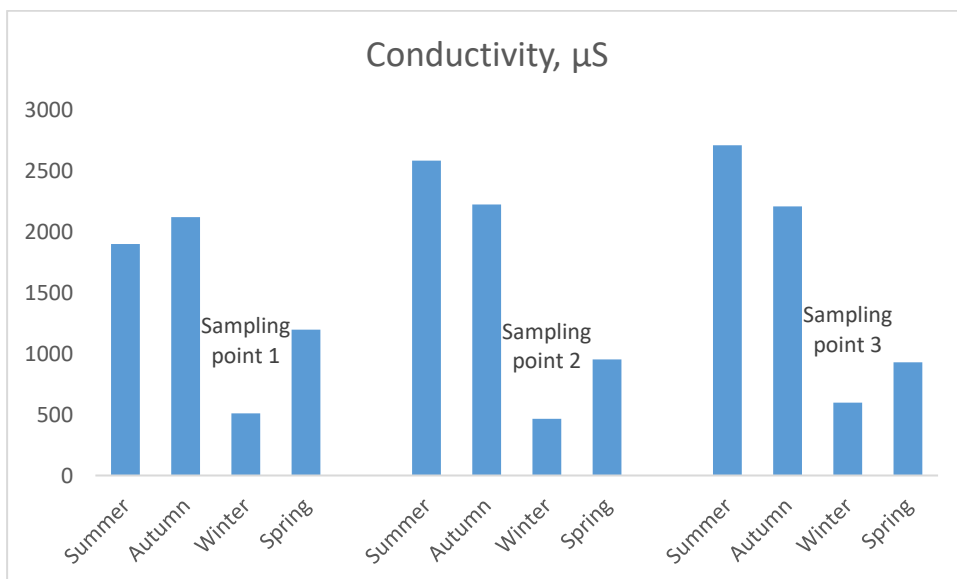
Figure 7. Seasonal graphic of electrical conductivity

- Results of analyses on samples from all three sampling points are similar.
- Salinity values vary between 0,185 and 2,708, with an increase observed in salinity during summer months.
- Oxidation parameters are not at a level of concern.
- Regarding nutrients, it is determined that there is only concern with respect to NH-H.

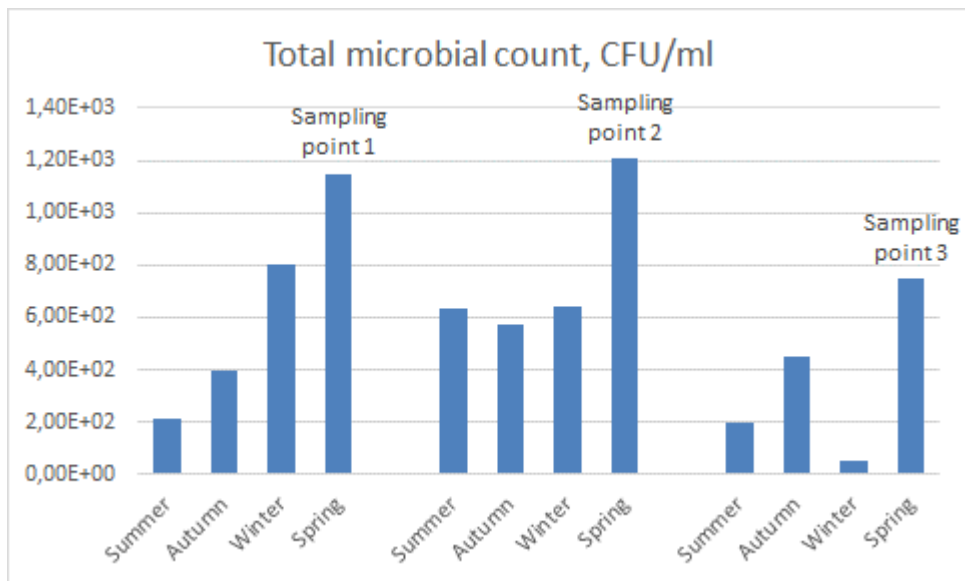
Figure 8. Seasonal graphic of faecal coliform values

- Lake water is determined to have faecal coliform contamination. As samples were taken from Lake' shore, intense human and animal activities caused increase in values in some months.
- In some months, Mn, Fe, and Pb contamination was determined.
- No Zn, Cu, Cr, Co, Ni, and Cd contamination was determined.

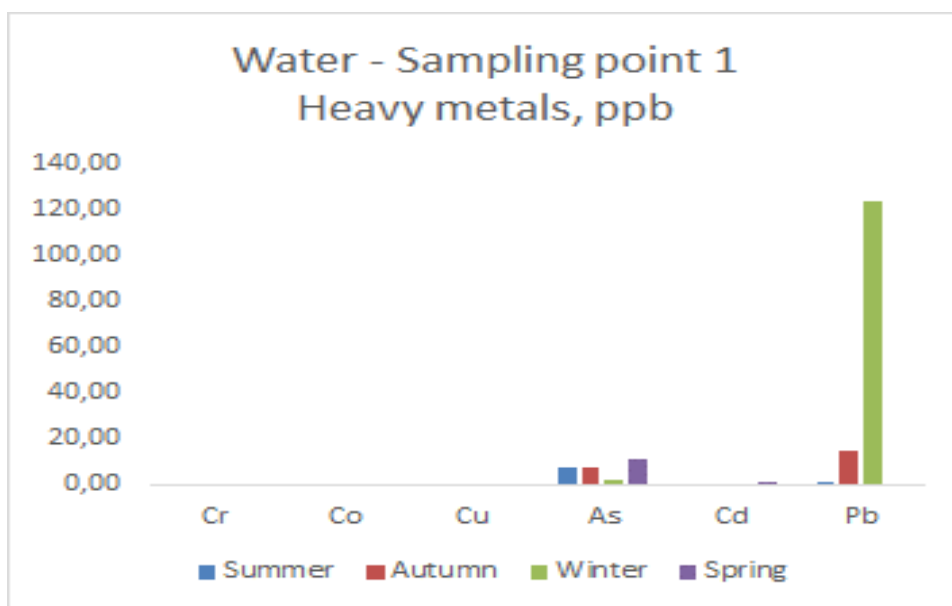
Figure 9. Seasonal graphic of heavy metal values of water samples taken from first sampling point

In terms of trace elements (metals) and Inorganic Contamination Parameters, no matter of concern was observed with the Lake water for Mn, Zn, Cu, Cr Co, Ni, and Cd while Fe was determined to be high in December 2017 and February 2018. Pb values were determined to be high in December 2017, January 2018, and February 2018 while classified as very good quality water for other months.

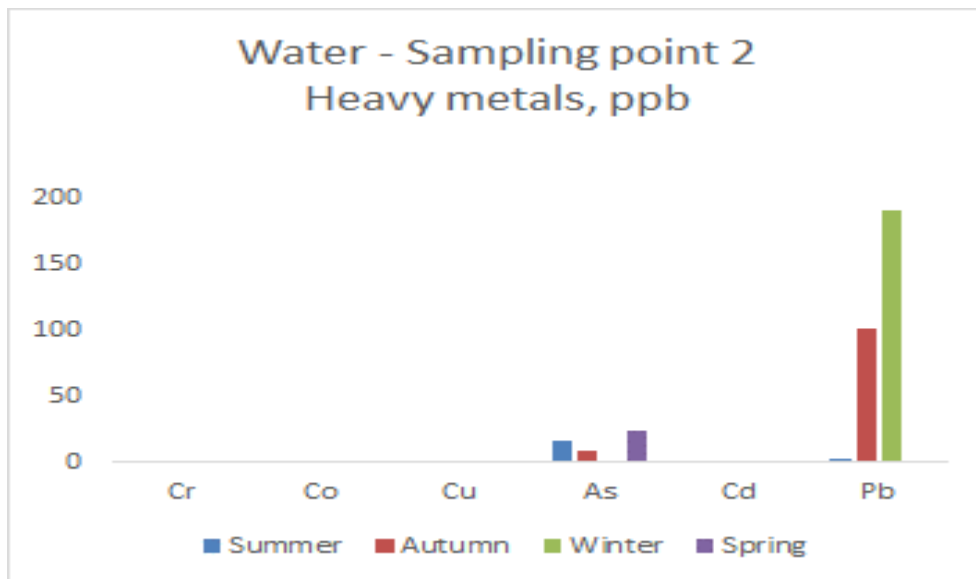
Figure 10. Seasonal graphic of heavy metal values of water samples taken from second sampling point

Of trace elements (Metals) and Inorganic Contamination Parameters, only Fe (January 2018 and March 2018) and Pb (November 2017, January-February-March 2018) values were determined to be at level of concern only in some months.

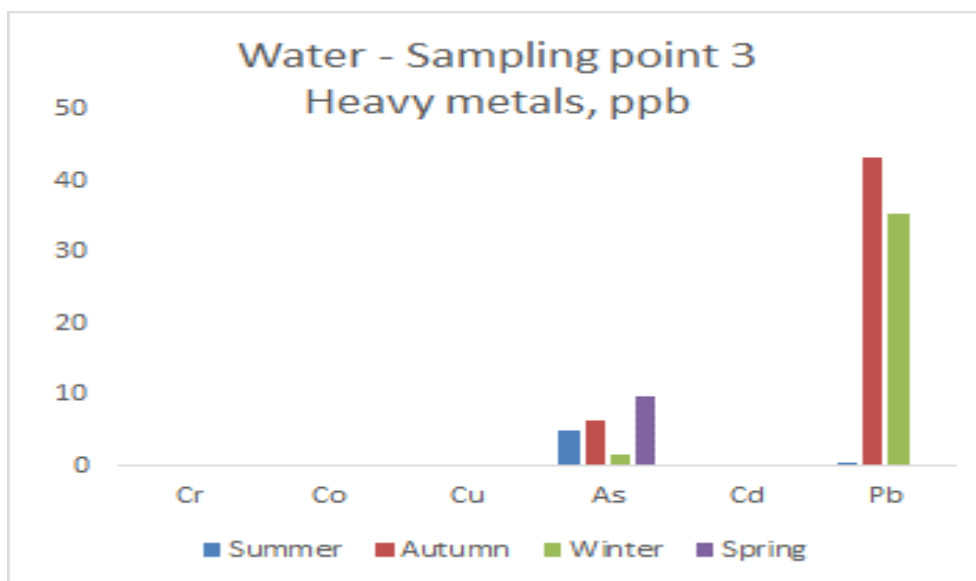
Figure 11. Seasonal graphic of heavy metal values of water samples taken from third sampling point

No Zn, Cu, Cr, Co, Ni, and Cd were found, and Pb values were classified under Class IV in December 2017 and January 2018.

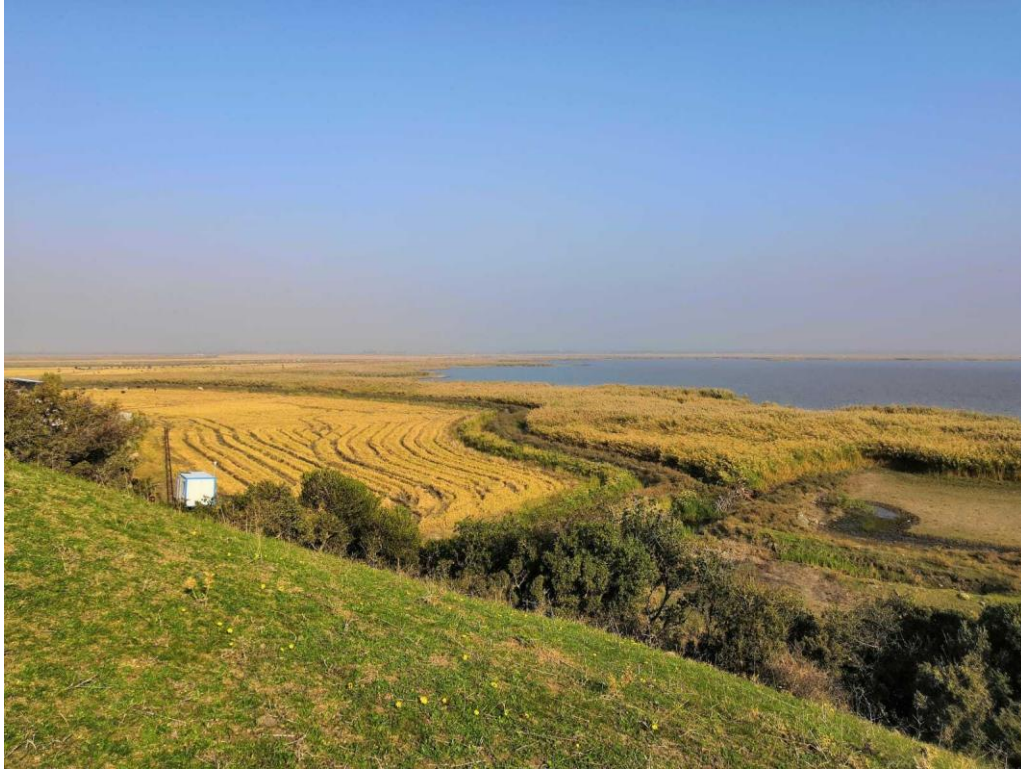
Image 4. Rice production next to Lake Gala

Due to intensive agricultural activities carried out around Lake Gala, the Lake is exposed to significant levels of organic and inorganic contamination resulting from flow of some of tail water from paddy fields in İpsala and Keşan regions, and flow of some of Ergene River's water into the Lake.

As great amounts of chemical composite fertilizers (20-20-0, 18-46-0) are used for rice production around the Lake, the available phosphorus quantity has reached high levels ($11,48 \text{ mg kg}^{-1}$ - $97,36 \text{ mg kg}^{-1}$). Though the phosphorus is washed out of the soil slowly, use of water-soluble fertilizers will enable washing to a certain extent in paddy cultivation where water in the paddy field is circulated continuously.
